Vibro-acoustic design of the stage floor reconstruction of a concert hall

F. Augusztinovicz¹, T. Kimpian^{1,2}

Abstract

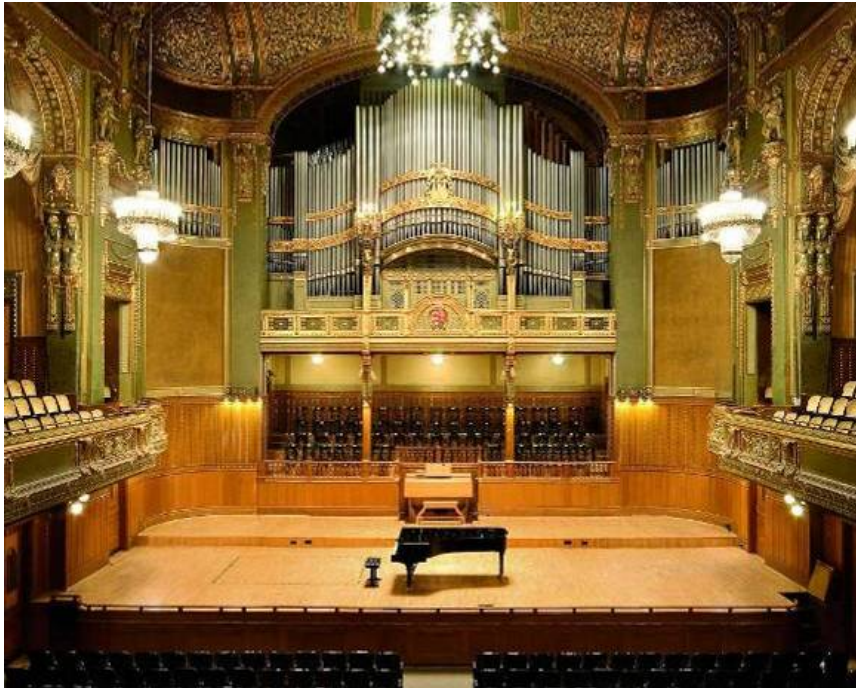
Figure 1: The stage under investigation

In the course of preparations of the renovation distinctive attention was paid to the restoration of stage construction, Fig. 1, which has to be newly rebuilt, with new stage technique installed. Nevertheless, the acoustical behaviour of the new stage may not differ much from the present one, which is regarded as very good both by musicians and audience alike. Therefore, an extended measurement series and subsequent analyses were planned and performed, in order to unravel the vibro-acoustic behaviour of the stage, to establish its most important parameters and to determine, which parts of the original structure have to be rebuilt in unvarying form and what can be changed, in order to meet the requirements of a recently built modern concert hall. This paper reports on the experiments and numerical simulations, performed on a selected part of the currently existing stage, as well as on some design variants of the new structure.

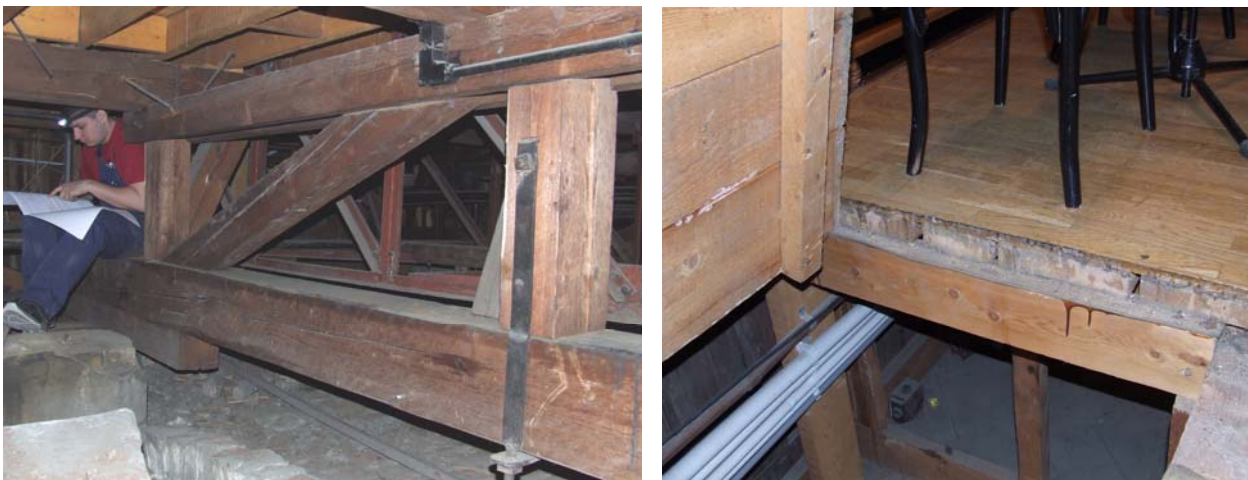
The stage essentially consists of heavy timber trusses, supporting the floor which is also made of timber, see Figure 2. The bottom-up order of layers of the floor is the following: 10×15 cm timber cross beams, 5×15 cm purlins at app. 40 to 50 cm spacing, 4×12 cm floor planking and 2 cm oaken parquet, with 2-3 mm thick plastic damping layers below and above the planking. The trusses are fixed by U-straps and a few screws, the planking and the parquet nailed. Large parts of the trusses are still original, but about one-fourth of the trusses was replaced by steel beams and the planking and parquet was replaced in the course of a reconstruction in 1976-77.

Figure 2: Wooden constructions of the stage

The whole structure has got in bad state of repair by today. Quite a few beams and purlins are twisted and/or cracked, some of them supported or fixed by timber wedges while other ones have loosened in the

course of time. Certain parts of the floor are rather solid, other parts however deflect a few cm when walking on the stage. Beyond its bad condition, the intention of the owner to ensure more storing place under the stage implies too that the stage has to be reconstructed. Nevertheless, musicians who regularly play in the concert hall have already got used to the stage, and there is general consent among them that the stage plays an important and favourable role in the outstanding acoustics of the hall.
